HIGH TEMPERATURE COMPATABILITY OF  $UO_2$   
WITH W-25 Wt % Re

R. A. Ekvall and J. O. Hegland

CONTRACT NAS3-2544

NUCLEAR THERMIONIC POWER OPERATION  
NUCLEAR TECHNOLOGY DEPARTMENT

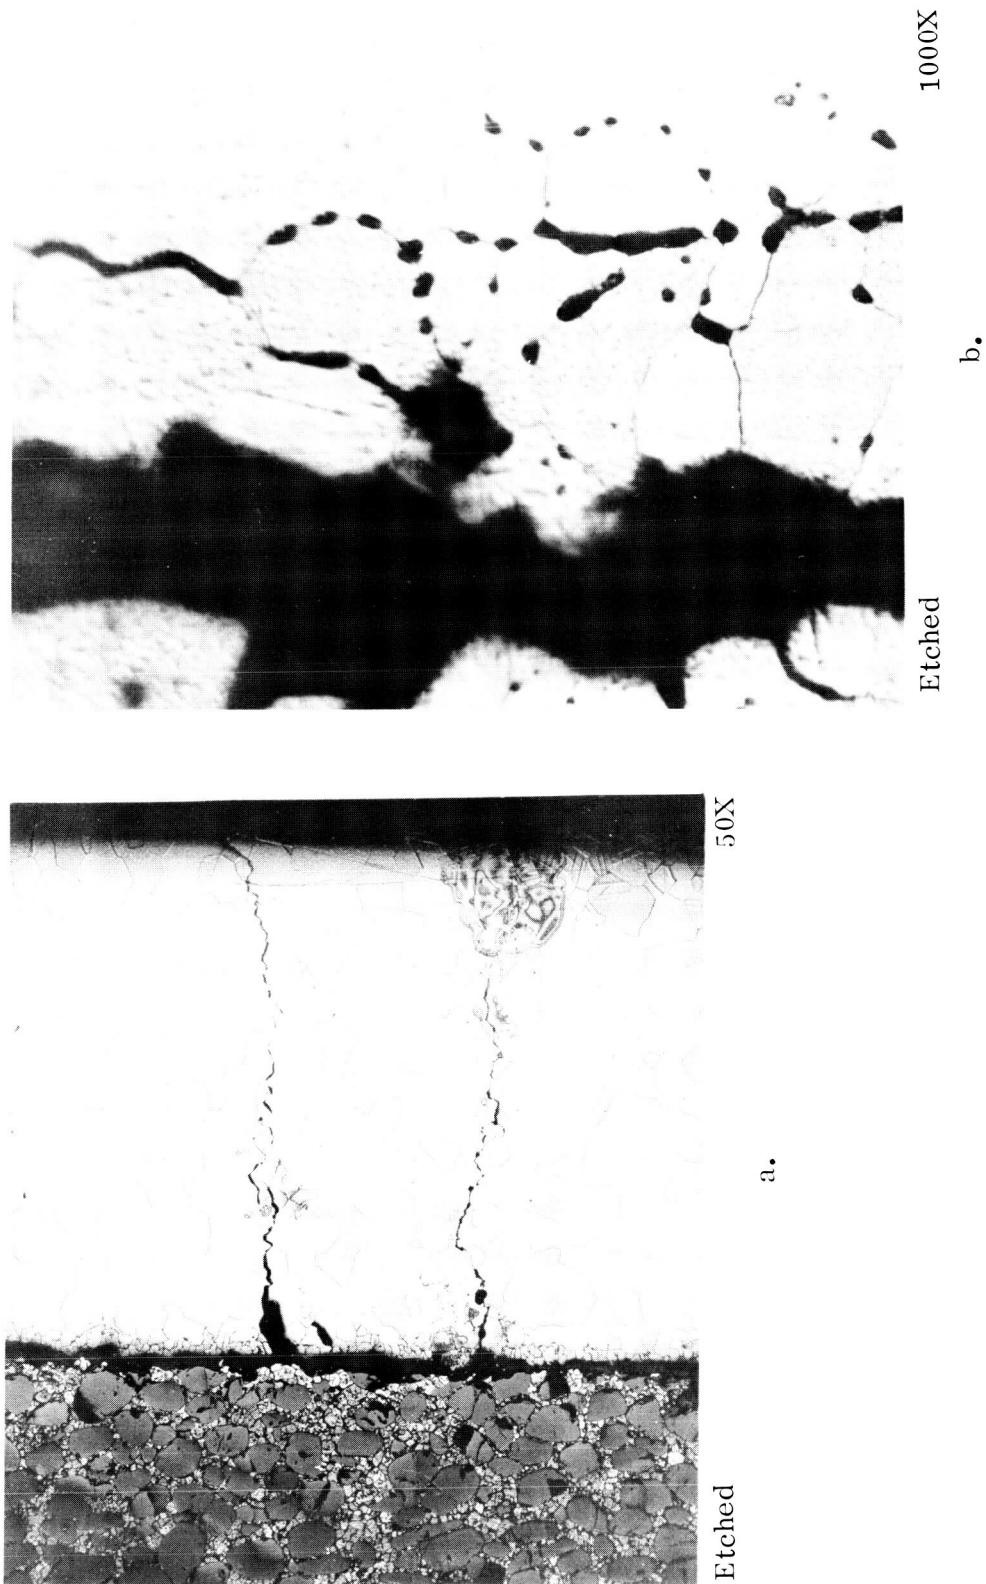
FIGURE 29. INTERFACIAL AREA OF CERMET/CLAD CAPSULE VWR-5 ANNEALED AT 1800°C FOR 500 HOURS. THE W/Re CLAD APPEARS WHITE

Figure 29 shows interfacial areas of the core and the container of capsule VWR-5 (70 v/o  $\text{UO}_2$ ) tested at  $1800^{\circ}\text{C}$ . A narrow zone of fine-grained metallic phase containing small intergranular nonmetallic inclusions (possibly  $\text{UO}_2$ ) was found along the interfacial edge of the container. This zone extended completely around the inner edge of the container and is more clearly shown at  $1000\times$  in Figure 29b. The core structure revealed  $\text{UO}_2$  penetration into the tungsten grain boundaries.

Hardness measurements were made on the container, the grains of the zone, and the tungsten core matrix. The zone proved to be intermediate in hardness (396 DPH) between that of the container (438 DPH) and the tungsten core matrix (360 DPH). In VWR-3 nonmetallic phase (possibly  $\text{UO}_2$ ) was observed in the grain boundaries in the W-25 w/o clad.

The black area between the core and the container was void and like the unidentified zone mentioned before, was continuous around the internal periphery of the container. The void was produced during thermal treatment and may have resulted from: (1) the core breaking away from the container; (2) the evaporation of  $\text{UO}_2$  from this region through cracks leading to the outside surface of the cladding; or (3) both these mechanisms. It is most likely that both mechanisms were operative. Interpretation (2) required that the  $\text{UO}_2$  be continuously connected. Examination of the microstructure of the rough area around the periphery of the core clearly shows that the  $\text{UO}_2$  has been interconnected because it escaped the capsule and left behind a skeleton of tungsten.
